## IMPORTANT TECHNICAL SERVICE BULLETIN : 1Z9-P8W4L-11

7-Pin Charge & Safety Breakaway Orientation on the Self-Resetting Breaker

2018 Oliver Legacy Elite II models built from August through November 2018

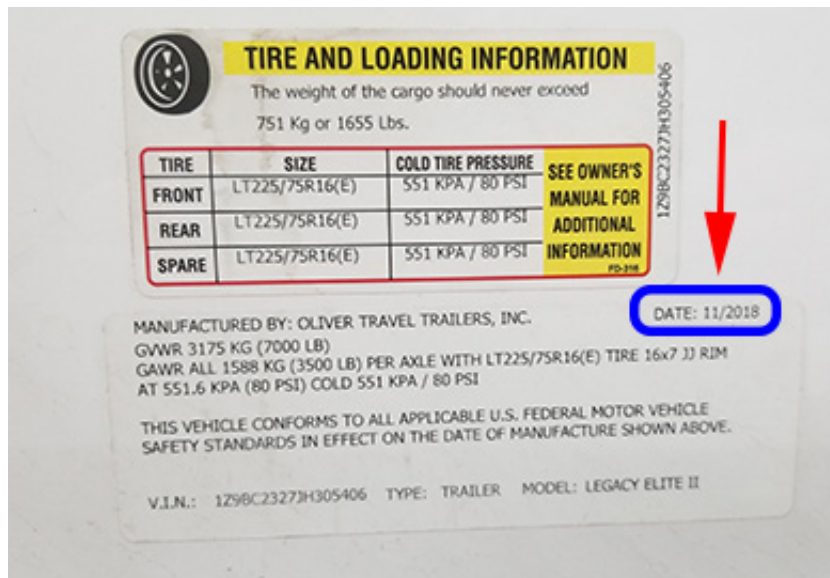
See sticker on lower shell on the street side to confirm the manufactured date on your trailer.

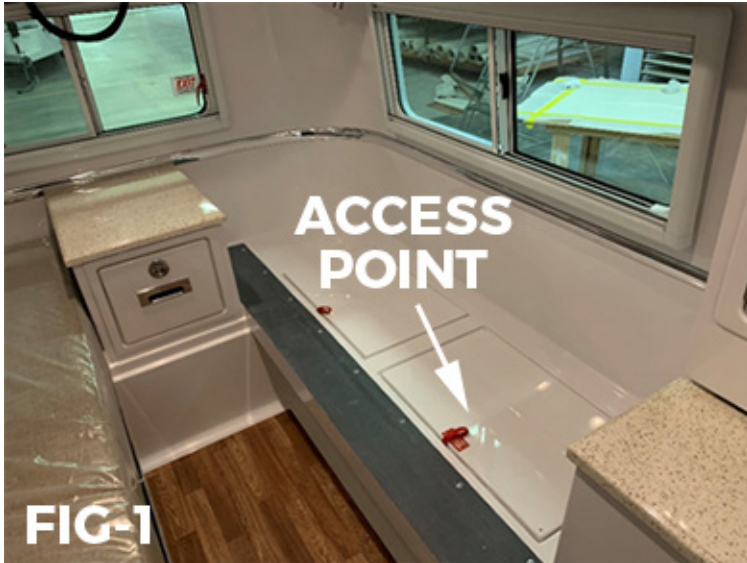
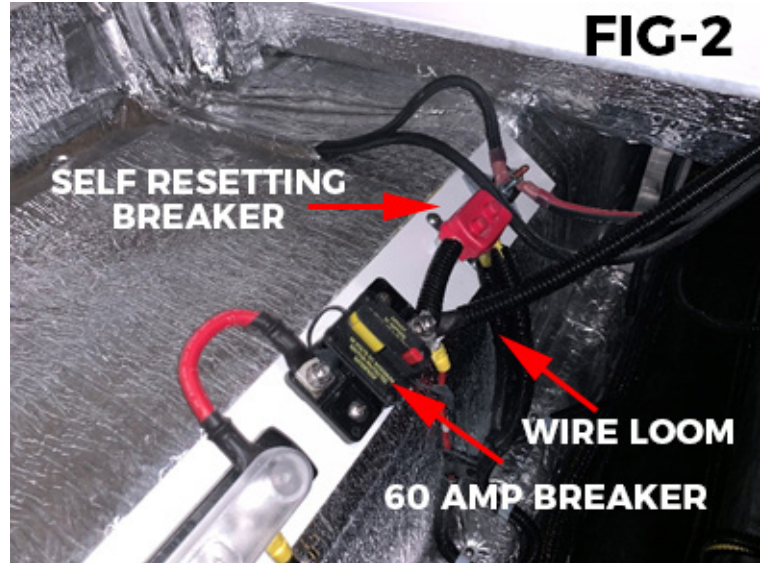
To access the parts to be inspected open the access point and look inside to the right to see the parts.

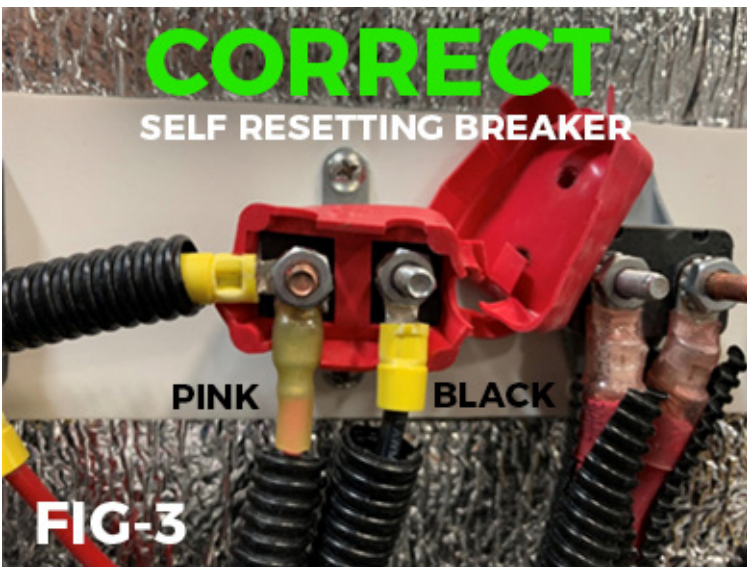
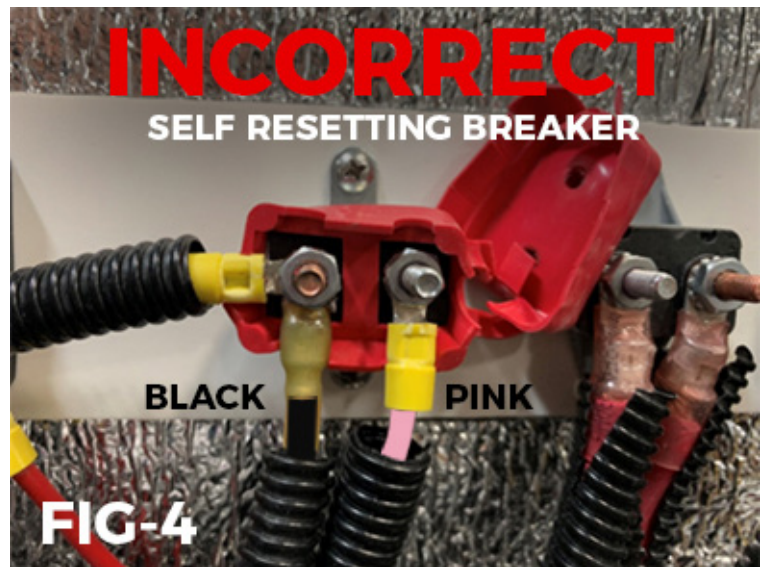
The self-resetting breaker is located immediately to the right of the 60 AMP breaker. This will have a red rubber cover on it, pull back the red cover to expose the terminals. Also pull back the black corrugated wire protection to determine the colors of the wire

If incorrect, follow the steps detailed in the corrective action instruction

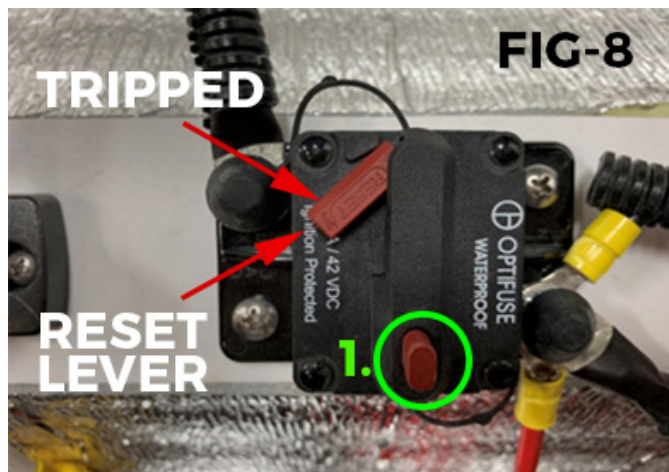
**This shows the 60 AMP breaker in its tripped condition. It can be manually tripped by depressing the red button (1) in Fig-8.**
