IMPORTANT TECHNICAL SERVICE BULLETIN - IMMEDIATE ACTION REQUIRED

Technical Service Bulletin for trailers equipped with optional inverter potentially improperly installed chassis ground wire or missing chassis ground wire.

Oliver Legacy Elite and Elite II models built on or after January 1. 2014.

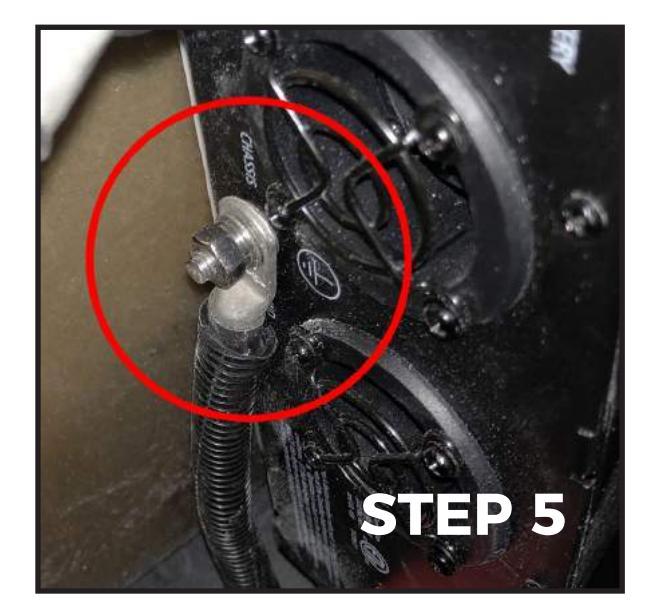
- 1. Go to the main circuit breaker panel located below the dinette and turn off the main 30-amp circuit breaker.
- 2. Unplug all 30-amp power cords from the camper, including the optional 30-amp convenience connection if installed.
- 3. Locate and disconnect the inverter's 4/0 positive wire followed by the inverter's 4/0 negative wire from the battery bank.
- 4. Locate the inverter in one of the lower street side compartments.
- Check whether there is a ground wire connected to the chassis ground terminal on the inverter. (Note: See Step 5 image)

- 6. If there **IS** a ground wire connected to the chassis ground terminal on the inverter, check that the appropriately-sized ring terminal has been installed and that the ring terminal **DOES NOT** have a flat washer between it and the chassis of the inverter.
- 7. If the ground wire **IS** installed with the appropriately-sized ring terminal and there is **NOT** a flat washer installed between the ring terminal and chassis, the issue is not present in your travel trailer. Please fill out the included inspection reply card and mail to address below using the postage provided return envelope :

- 8. If there is **NOT** a ground wire connected to the chassis ground terminal on the inverter, please follow the CORRECTIVE ACTION INSTRUCTIONS FOR INSTALLING A MISSING INVERTER CHASSIS GROUND WIRE.
- 9. If the ground wire was installed improperly using an ring terminal that is oversized, please follow the CORRECTIVE ACTION INSTRUCTIONS FOR IMPROPERLY-SIZED RING TERMINAL INSTALLED ON CHASSIS GROUND WIRE.
- 10.If a flat washer was installed between the ring terminal and chassis, **please follow the CORRECTIVE ACTION INSTRUCTIONS FOR FLAT WASHER INSTALLED BETWEEN 1/4" RING TERMINAL AND INVERTER CHASSIS.**
