## IMPORTANT TECHNICAL SERVICE BULLETIN : 1Z9-P8W4L-11

7-Pin Charge & Safety Breakaway Orientation on the Self-Resetting Breaker

2018 Oliver Legacy Elite II models built from August through November 2018

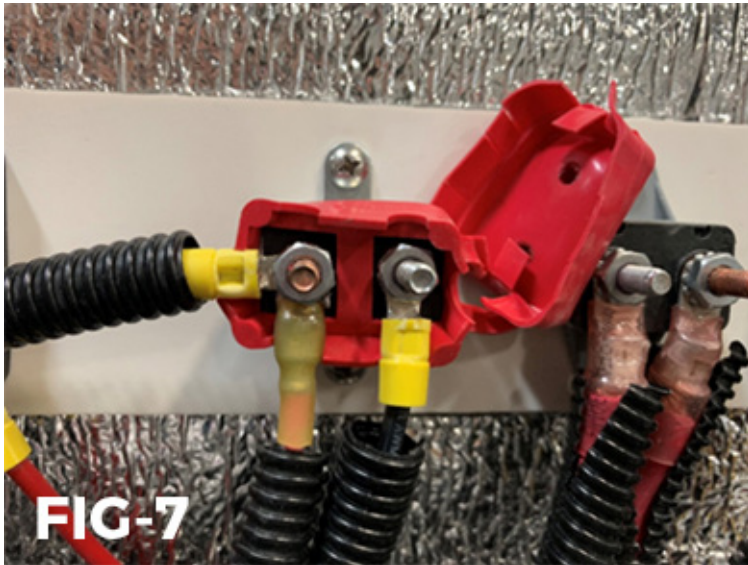
**Note: The 60 AMP breaker can have a reset lever that is either Red or Yellow in color.**

Once you have reconnected the battery and checked that the 60 AMP breaker has not tripped during this procedure, this concludes the resolution. If the 60 AMP breaker needs to be reset please refer to Fig. 1 and Fig 2. Below.
